Conservation of Decorated Plaster Ceilings
in the
Council Chamber and Assembly Room
of the
Colonial Building, St. John's, Newfoundland

Historic Plaster Conservation Services Limited
Craig Sims: Heritage Building Consultant
Jablonski Building Conservation, Inc.

Historic Plaster Conservation Services Limited was contracted by the Government of Newfoundland and Labrador to execute a conservation plan on the ceilings of the Council Chamber and Assembly Room of the Colonial Building.

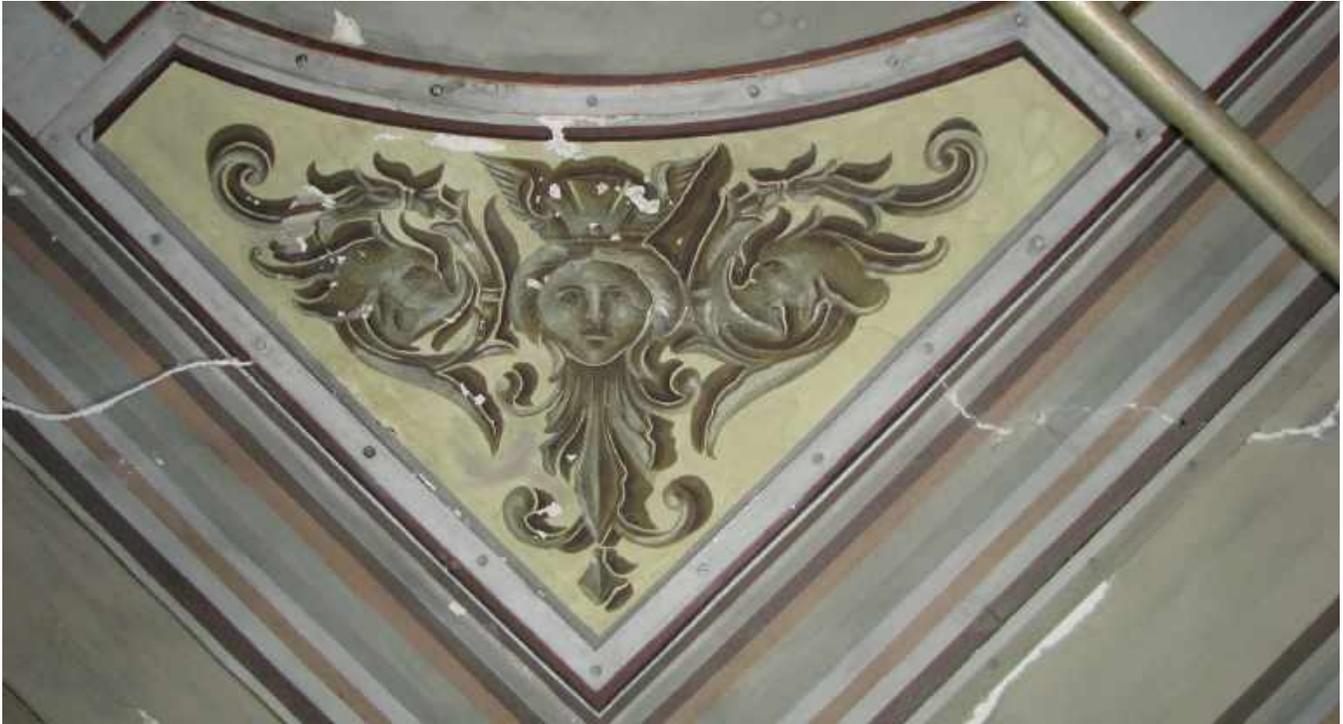
ABOVE The Murphy frame in this case is made to follow the perimeter of the Pindikowski painting.

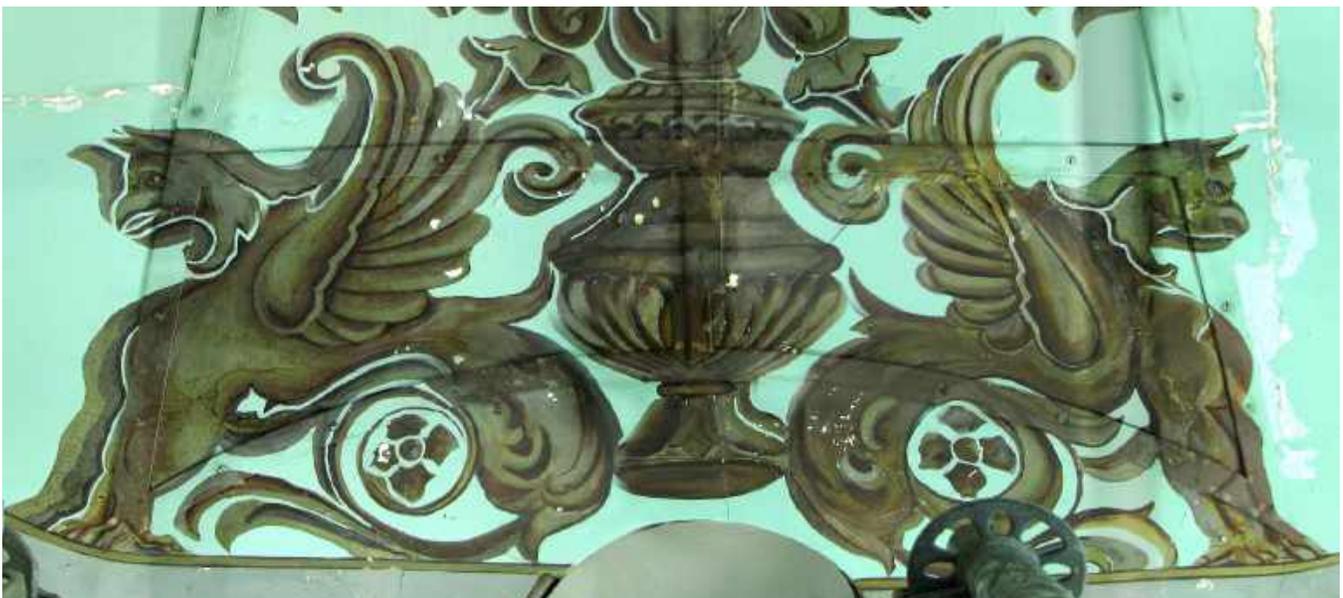
BELOW Here the ingenious Murphy frame intersects the freehand painting details and has caused the need for extensive “infill” or repainting of the Pindikowski original. It is not possible to determine the condition of the ceiling at the time Murphy did his work, but it is reasonable to assume that the work was essential to saving the paintings and that the intervention was the minimum required to accomplish this. The conservation of these freehand portions of the known Pindikowski decoration was undertaken by conservators from Jablonski Building Conservation.

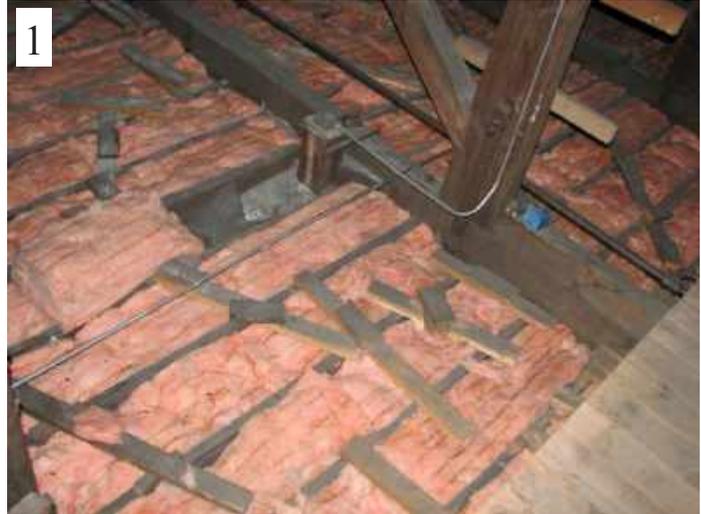
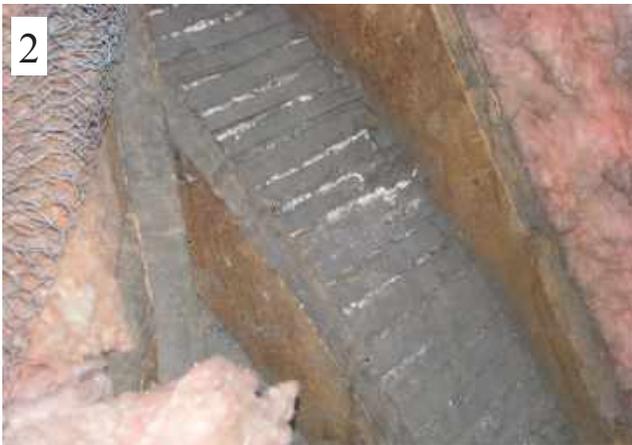
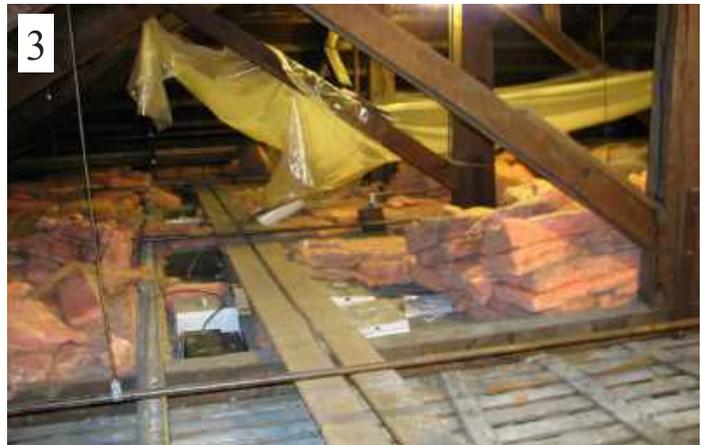
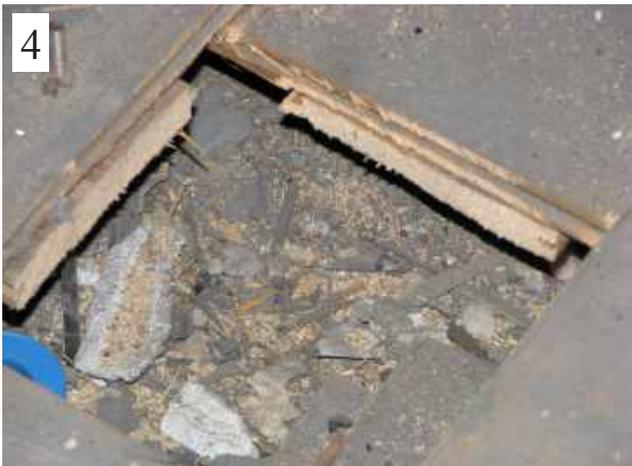
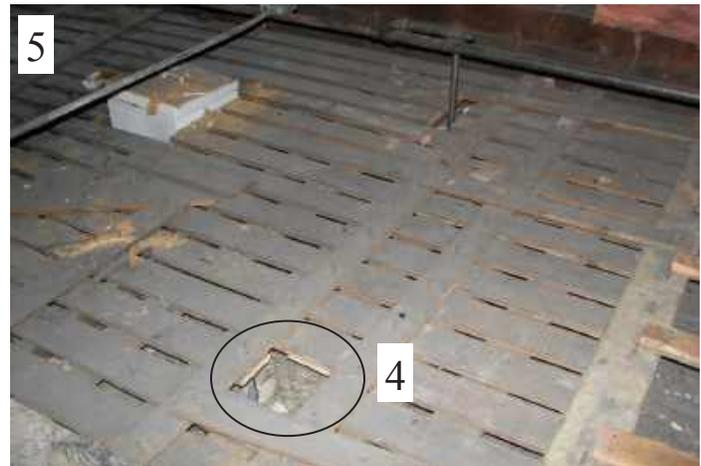
- 1 *Insulation had to be removed to provide access.*
- 2 *It became apparent that the insulation had been placed in the attic directly on top of the debris from the 1939 fire.*
- 3 *Once exposed, it was easy to see the deteriorated condition of keys and lugs that are essential to support a plaster ceiling.*

- 4 *Under the “Murphy Bolt” catwalks in the attic over the Assembly Room, the debris from the 1939 fire and before was found essentially undisturbed .*
- 5 *The “Murphy Bolt” catwalk system had to be removed so that the debris could be cleaned up and access to the upper side of the plaster ceilings gained. This work could not be done until the ceilings were temporarily supported by a plaster beam support system or falsework provided by HPCS.*

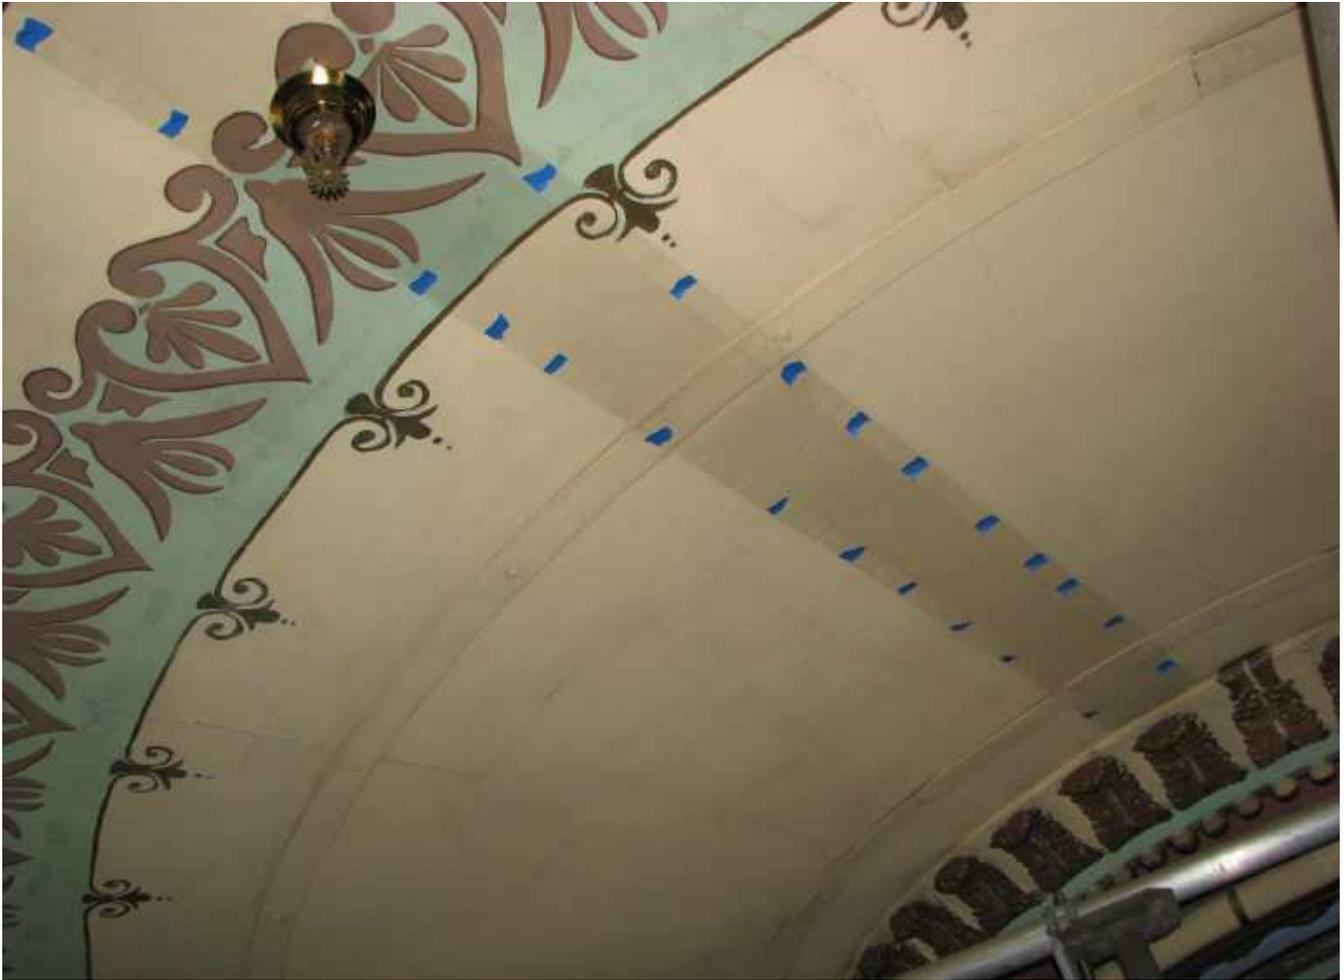
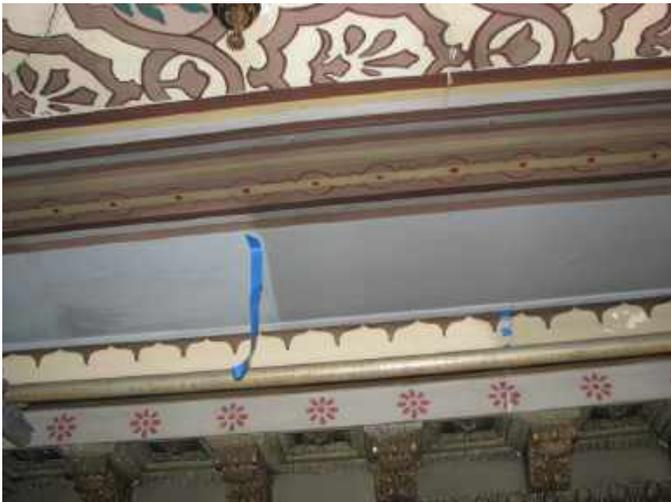
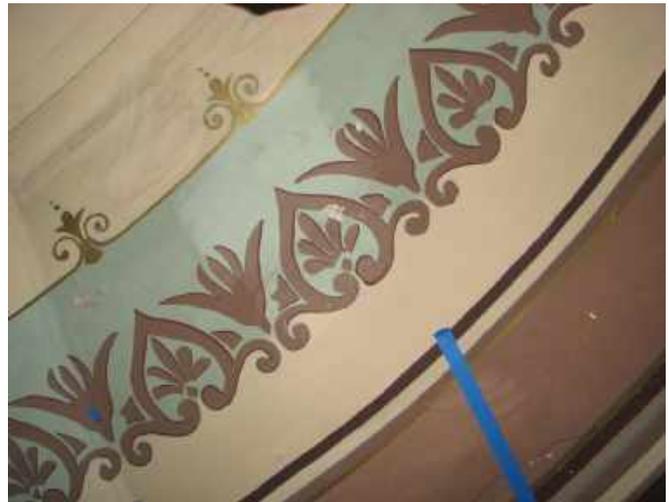
ABOVE The images are all from the Council Chamber ceiling. Cleaning with plain water was quite effective and considered to be more than adequate. Only gentle scrubbing action was required to dislodge the dirt. No paint loss was observed.

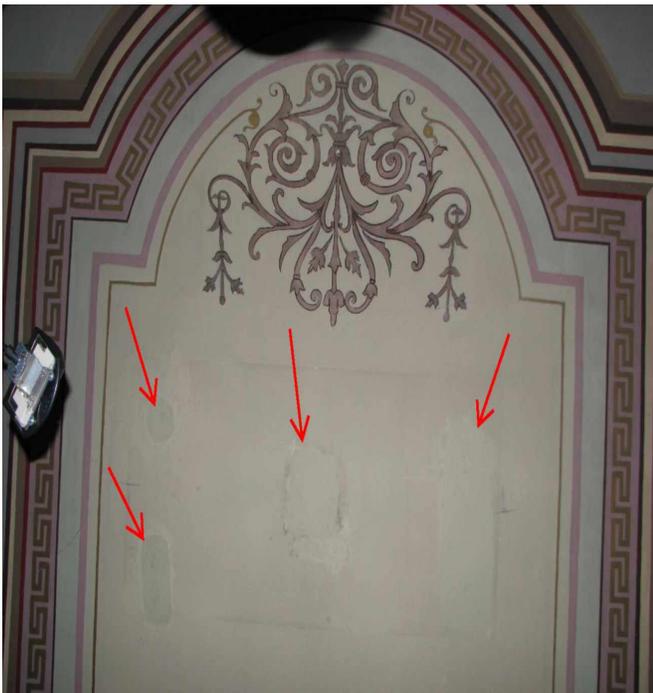
Holes in the soffit had previously been patched with adhesive paper and printed to more or less match the ceiling.

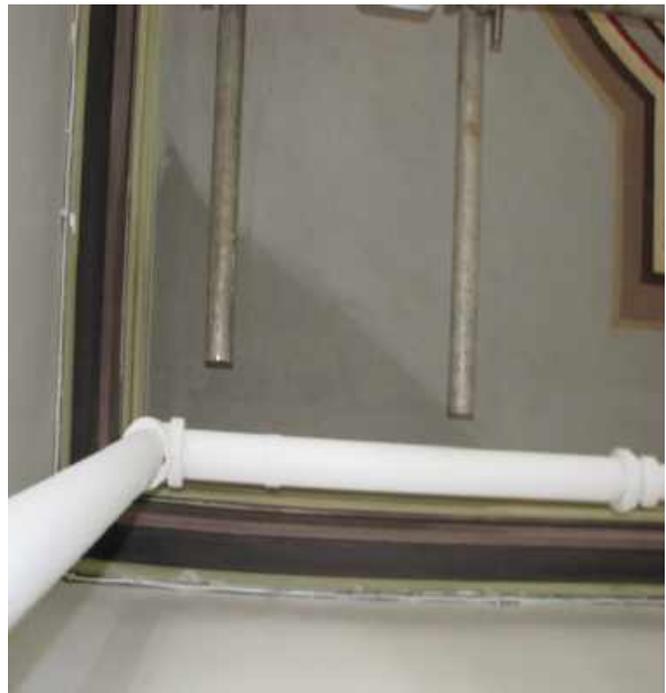
Triangular section (southeast corner) of CC ceiling left uncleaned for client review.

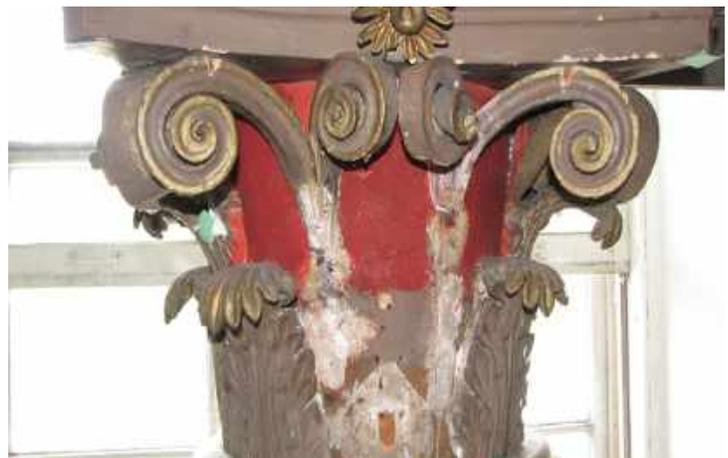
ABOVE Capitals and other ornament below the galleries were in particularly distressed condition.

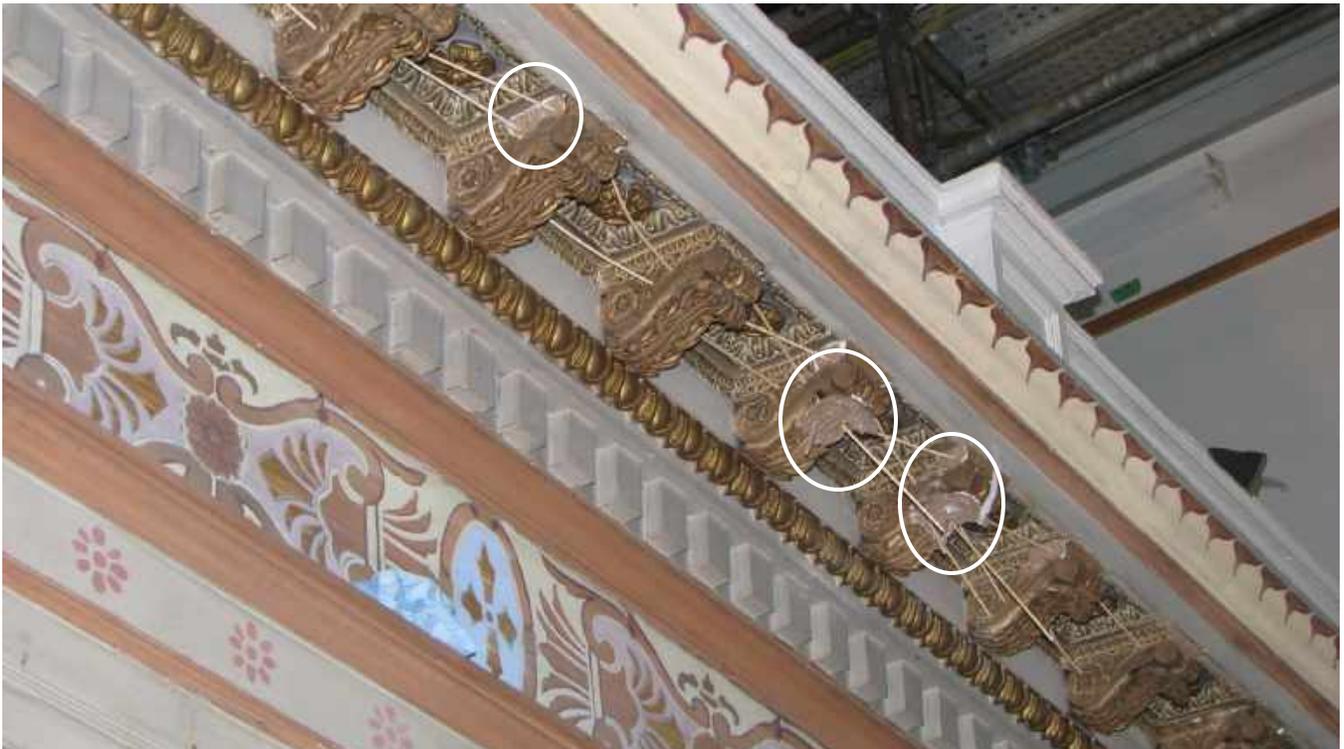
BELOW A substantial number of acanthus leaves' tips were missing and had to be replaced with replica parts cast from original samples.
