Conservation of Decorated Plaster Ceilings
in the
Council Chamber and Assembly Room
of the
Colonial Building, St. John's, Newfoundland

Historic Plaster Conservation Services Limited
Craig Sims: Heritage Building Consultant
Jablonski Building Conservation, Inc.

Historic Plaster Conservation Services Limited was contracted by the Government of Newfoundland and Labrador to execute a conservation plan on the ceilings of the Council Chamber and Assembly Room of the Colonial Building.

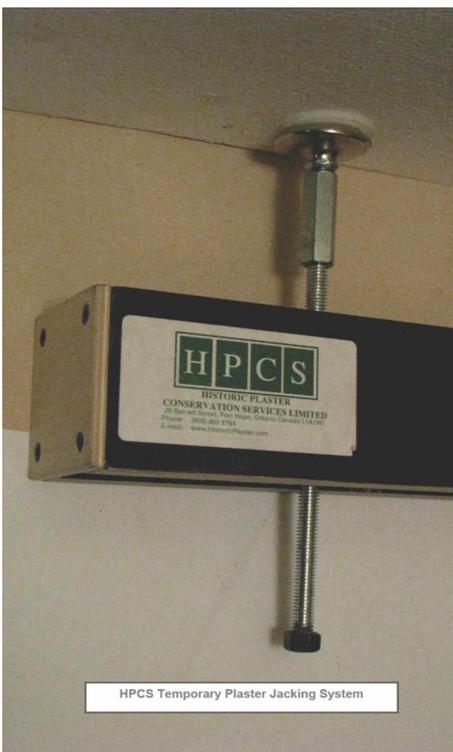
ABOVE and BELOW Before the attic could be safely cleaned, a system of plaster support beams was put in place to carry the weight of the plaster. 260 beams were used, each providing up to 12 individually adjustable support points. The ceiling surface was protected by a soft foam pad attached to the contact point. Because the system offers great flexibility, the individual contact points could be selected on the basis of providing support and not damaging any “freehand” Pindikowski painting.

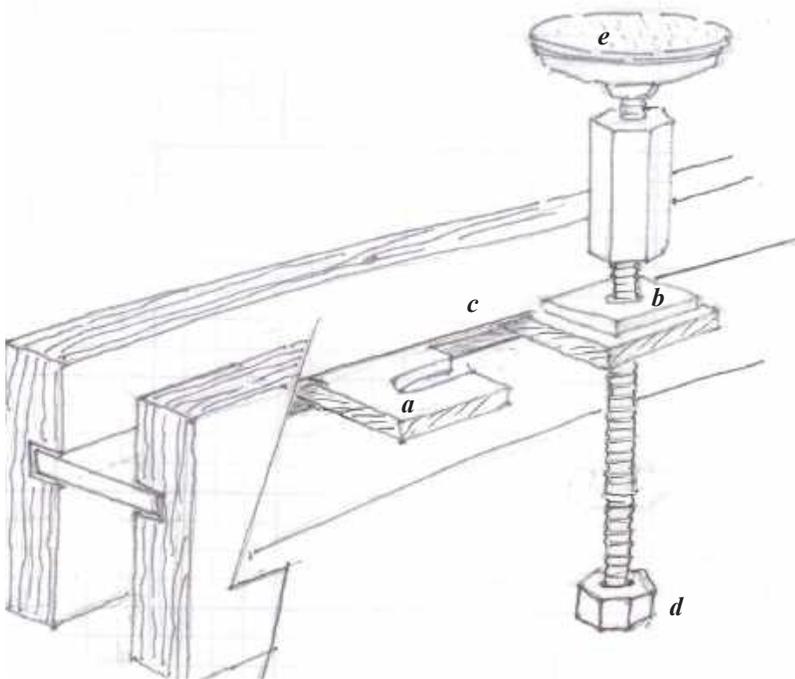
BELOW A special temporary beam system has been devised by HPCS for the specific purpose of supporting plaster and wood lath ceilings during their conservation treatment. Beams are supported in their working position by an industry standard scaffolding system referred to as "System Scaffolding". The SS forms a base working platform 7' below the ceiling and additionally, support for a rigid overhead superstructure directly below the ceiling on which the HPCS temporary beam system is installed. The HPCS beams are typically 8' long and each has a capacity for 12 individual jacking points along its length. Using the HPCS beams in a grid of 16" to 24" centres, it is possible to gain a very direct, as needed support beneath a delicate delaminated ceiling and still have access to the surface for observation and delicate manipulations.

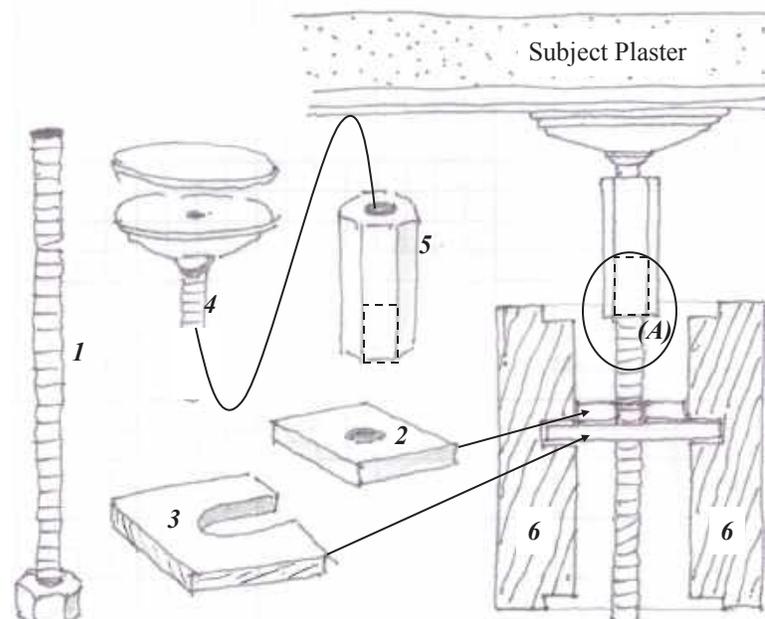
RIGHT Component parts of the HPCS temporary beam system are illustrated. The connection at (A) is not threaded as might be expected but simply a slip fit. This allows the jacking shaft (1) to be threaded onto block (2) and positioned along the beam on a convenient jack support slide (3). This done, the technician slips the pre-assembled parts (4) and (5) over the end of the jacking shaft (1) and tightens the nut to the specified tension. Beam Rails (6) are made from 1" Baltic birch ply with 20 laminations per inch.

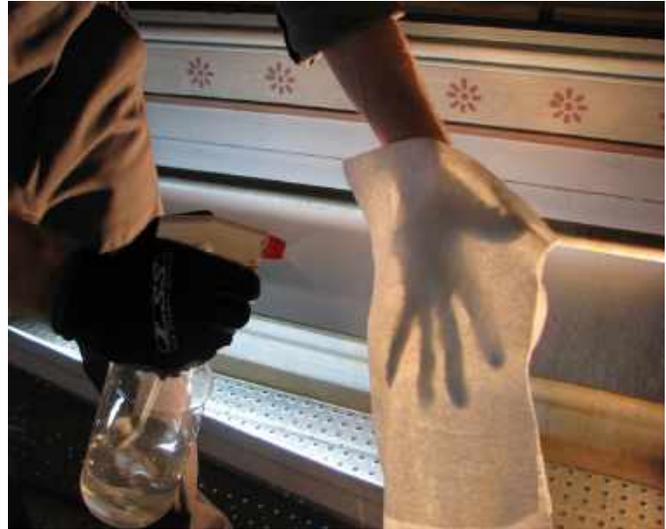
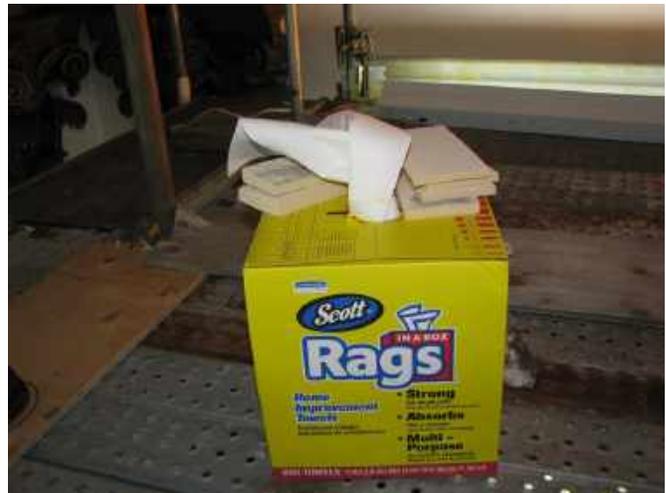
Heavily sooted areas were first cleaned with a gentle air wash. These were areas that probably had not been cleaned since the 1939 fire because they were hidden or difficult to reach.

The cleaning method was a light spray of distilled water on clean Scott industrial towels. The towels are non-woven highly absorbent shop towels.

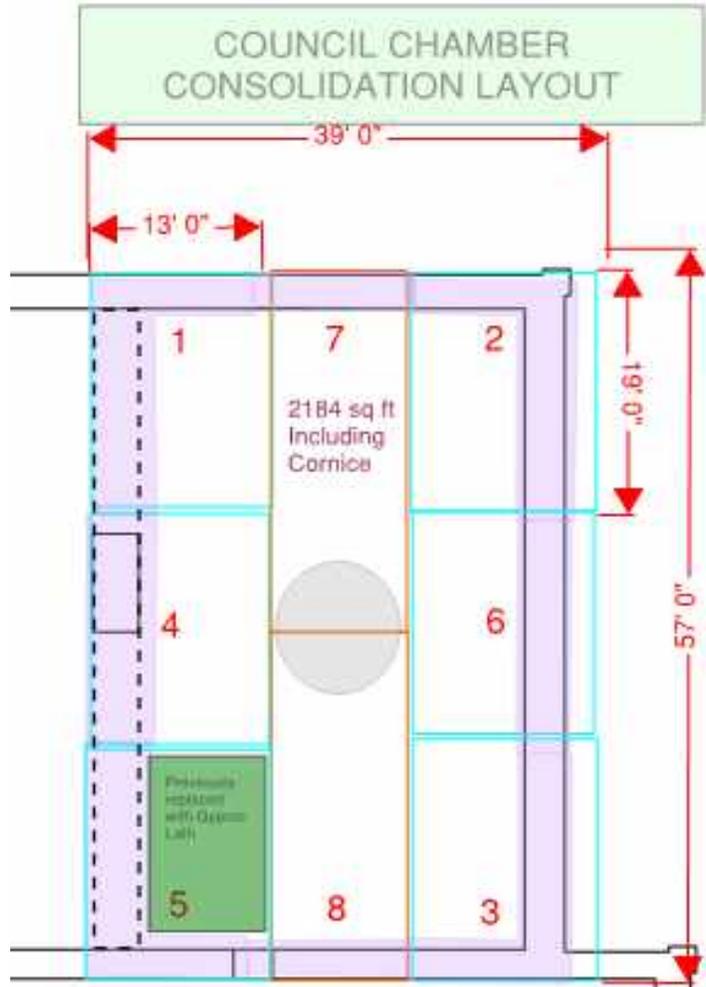
Sector 5 has a significant replacement area as marked. This area was given a thorough application of material to make it easy to clean in future.

Schematic representation of the Committee Chamber divided into sectors for treatment. The mauve perimeter represents the area of the cornice relative to the area of the flat ceiling.

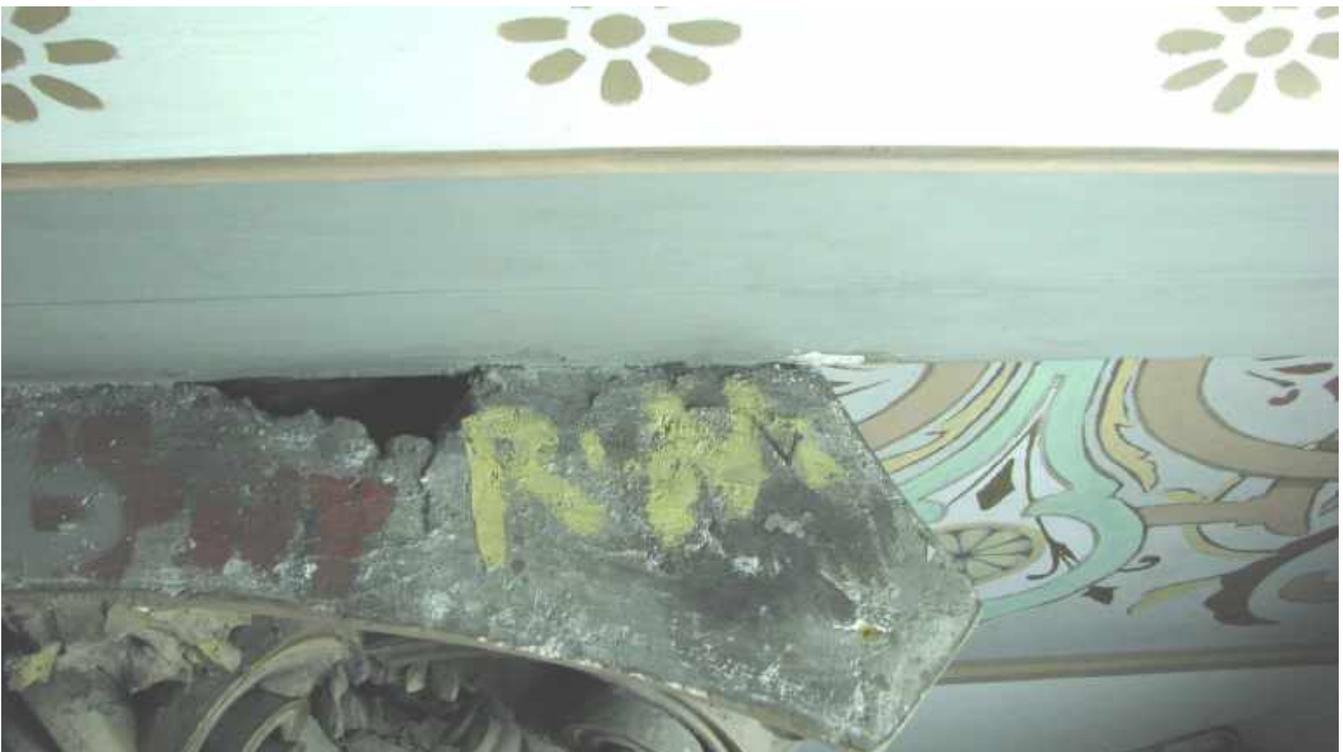
ABOVE This 1946 signature and the initials J.T. appear on the top ledge of the great Corinthian capital in the northeast corner of the room.
