FEATURE | Concrete & Masonry

Ancaster town hall facelift preserves the past

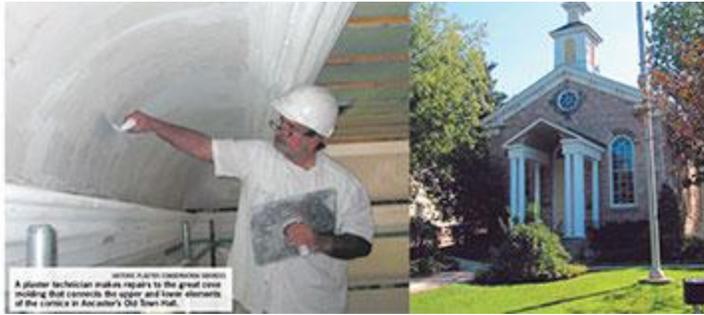
HISTORIC PLASTER CONSERVATION SERVICES

A plaster technician makes repairs to the great cove molding that connects the upper and lower elements of the cornice in Ancaster's Old Town Hall.

Stewart is also inspecting the ceiling's damaged cornice structure and installing supplementary mechanical fastenings to stabilize it. The month-long project is expected to conclude by the end of September.
